Name Of Dam: —TIMBER LAKE DAM  
Location: FAIRFAX COUNTY  
Inventory Number: VA. 05918

# PHASE I INSPECTION REPORT

## NATIONAL DAM SAFETY PROGRAM

TIMBER LAKE DAM  
FAIRFAX COUNTY, VIRGINIA  
INVENTORY NO. VA 05918

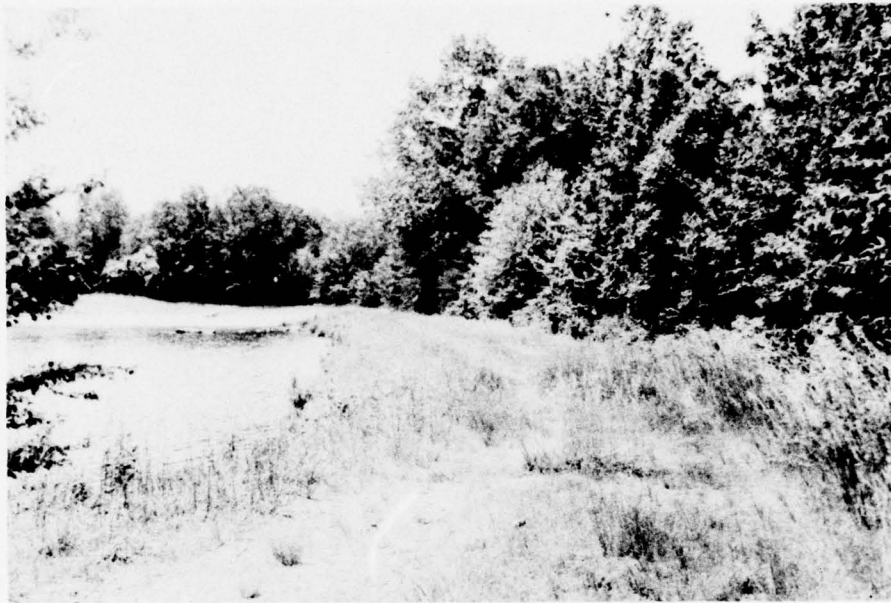
Top of Dam

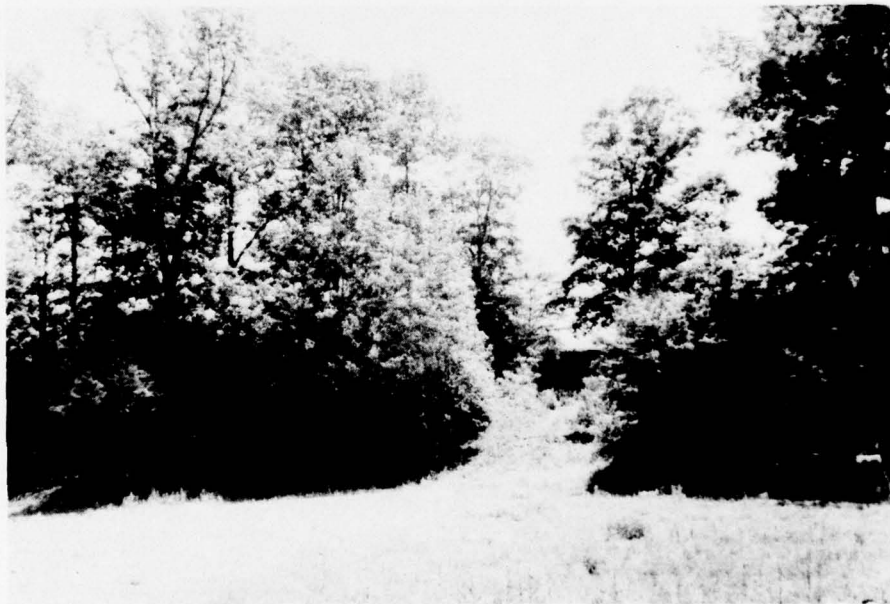
Downstream Face of Dam

About 100 feet from the right abutment a very wet area was observed on the downstream slope of the dam, about equidistant from the toe and the crest. This area was about 8-feet x 3-feet, the longer dimension being parallel to the axis of the dam. There is evidence of sloughing in this wet area. Other smaller wet areas and sloughs were observed elsewhere on the downstream slope, generally on the lower half of the slope indicating that the phreatic surface exists along the downstream slope about halfway down from the crest.

\*6.2.2 The entire toe of the dam was very spongy and wet with evidence of sloughing. At the base of the right abutment there is a pool with out 0.5 gpm flowing into it. Although dams that are built without internal drains do sometimes seep, an investigation should be conducted to determine the effect of the seepage on the stability of the dam. Evidence of ground movement was also noted on the downstream slope at the time of inspection.

7.2 Remedial Measures/Recommendations: Action should be taken to determine the stability of the dam. It is recommended that samples of soil from the embankment and foundation be analyzed in the laboratory for use in a stability analysis and that remedial actions resulting from this further investigation be implemented. The owner should, through his regularly scheduled maintenance program, repair the gullies and sloughing in the embankment. The seepage and possible movement of the embankment should also be monitored to determine their effect on the stability of the embankment.

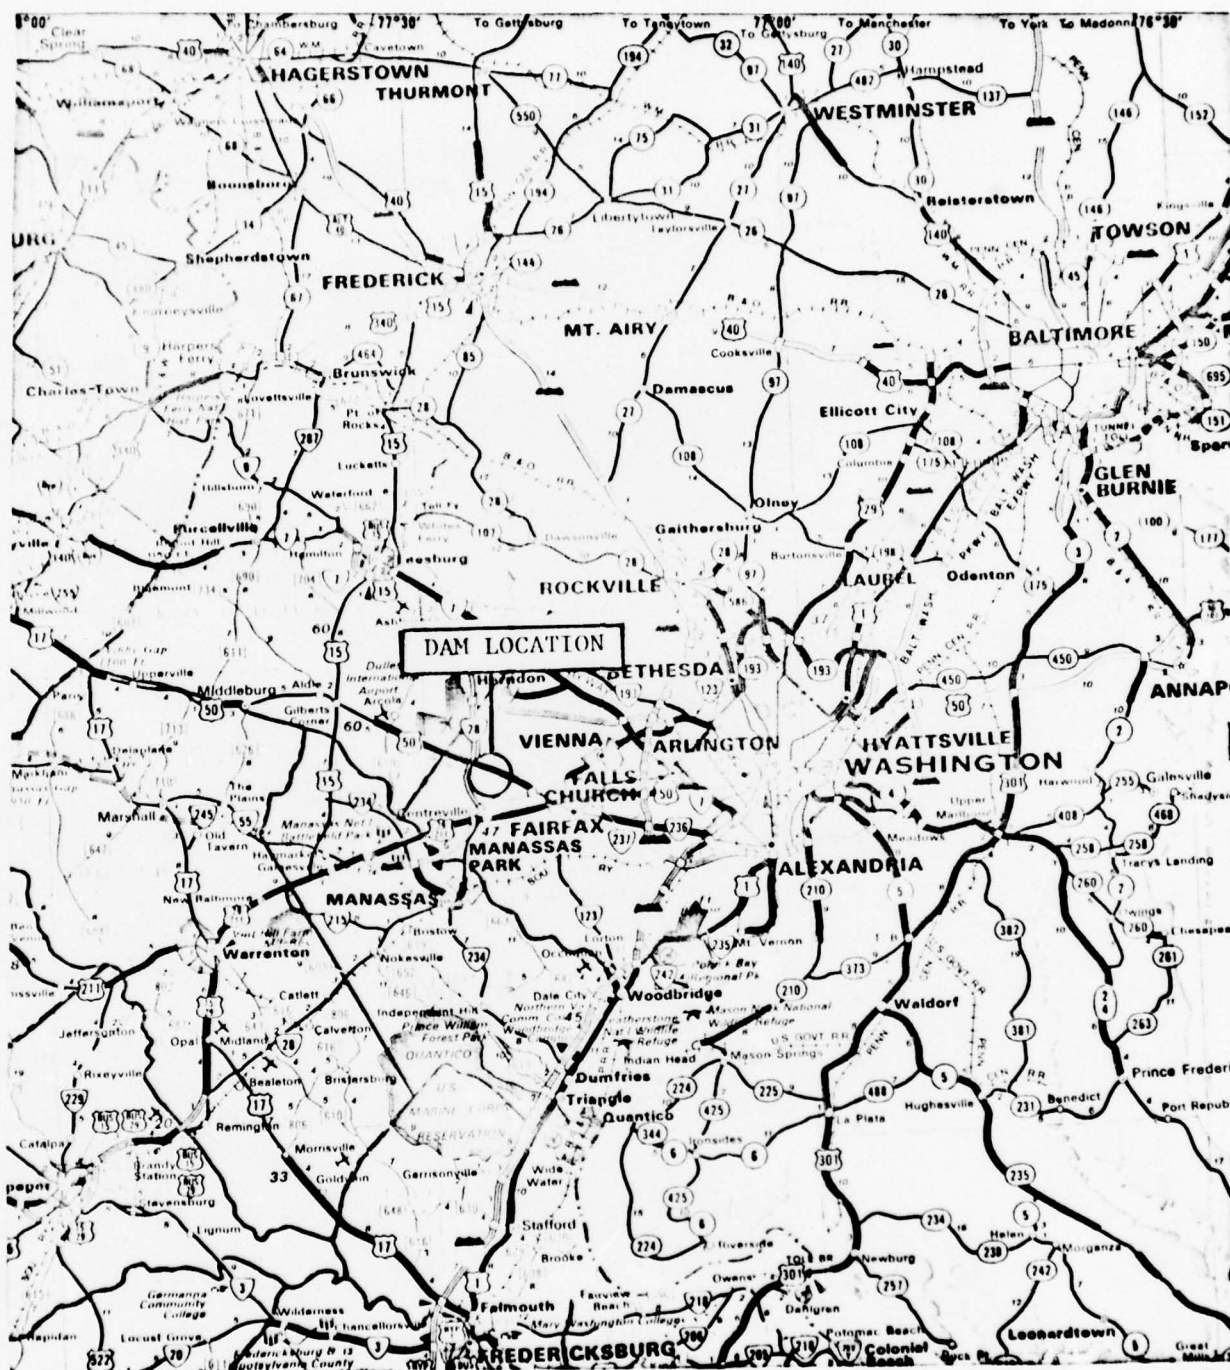
PLATE 1 OF 2

Timber Lake Dam is located in the County of Fairfax west of Vienna. The dam is one half mile north of State Route 627 about 3 miles east of Vale, Virginia. The dam is an earth embankment about 400 feet in length. The dam is 30 feet high from the crest of the embankment to the streambed at the downstream toe of the dam. The top of the dam is 12 feet wide. The dam is classified as small size and significant hazard. The dam is owned by Mr. Joe Young. The purpose of the dam is for recreation i.e. swimming, boating and picnicking. The principal spillway consists of a drop inlet with three sides open connecting to two 24-inch pipes extending through the embankment. There is an emergency spillway located to the left of the dam. This spillway consists of a 150 foot wide grass section with an elevation approximately 6-inches lower than the crest of the dam (see Plate 1, Appendix I.)

2.3 Operation: In 1972, as a result of heavy rain and flooding, the emergency spillway to the left of the dam was eroded. The emergency spillway was repaired shortly after the flood and the drop inlet (principal spillway) and two 24-inch diameter pipes were installed (see Plate 1, Appendix I.)

An emergency spillway is located to the left of the dam. This spillway is approximately 150 feet wide with an elevation 6 inches lower than the crest of the dam (see Plate 1, Appendix I). The spillway is covered with grass, except along the shoreline where sand has been placed for use as a beach.

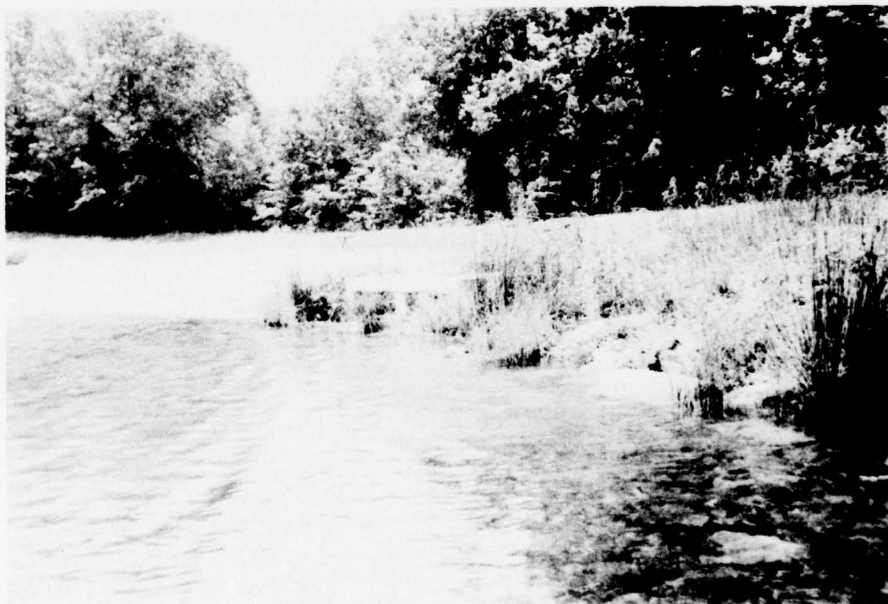
PHOTOGRAPH NO. 2  
Principal Spillway Intake Structure

3.1.3 Spillway: The principal spillway consists of a concrete drop inlet with 1-foot x 2-foot openings (at elevation 341.0) on each of three sides. Two 24-inch diameter concrete pipes run from the drop inlet through the dam.

VISUAL EXAMINATION OF	OBSERVATIONS	REMARKS OR RECOMMENDATIONS
CRACKING AND SPALLING OF CONCRETE SURFACES IN OUTLET CONDUIT	None visible at lake level	
INTAKE STRUCTURE	Concrete drop inlet open on 3 sides with six 1-foot x 2-foot openings.	Observation made from top of drop inlet.
OUTLET STRUCTURE	Two 24-inch diameter pipes from drop inlet. 4-inch pipe to siphon to lower lake	4" pipe to siphon.
OUTLET CHANNEL	Over grown with bushes.	
EMERGENCY DRAWDOWN	Small electric pump can be used to siphon water from reservoir or pump water into reservoir.

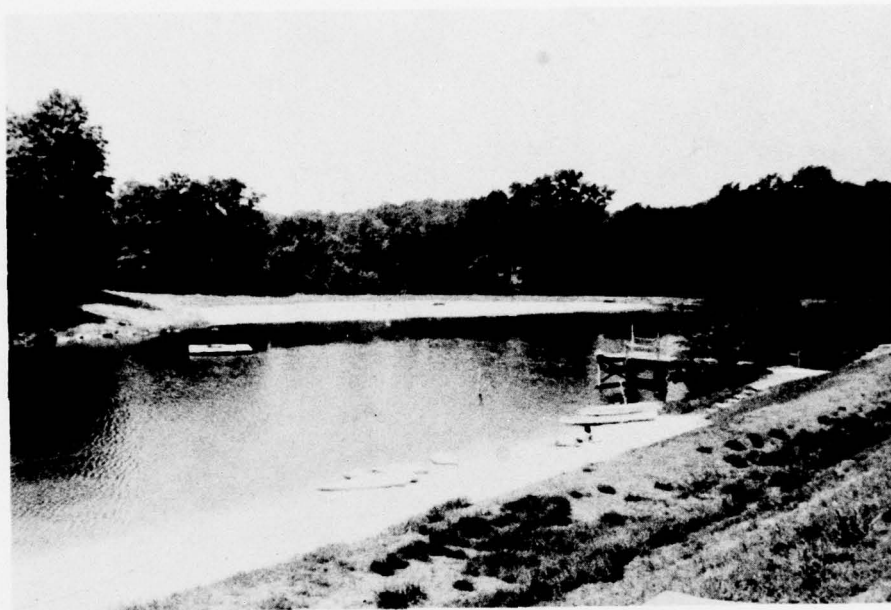
PHOTOGRAPH NO. 3  
Emergency Spillway

VISUAL EXAMINATION OF	OBSERVATIONS	REMARKS OR RECOMMENDATIONS
CONCRETE WEIR		
APPROACH CHANNEL	150-foot wide grass channel, 6" below elevation of the dam. A small sandy area at the water line is used as a beach.	
DISCHARGE CHANNEL		
BRIDGE AND PIERS	None.

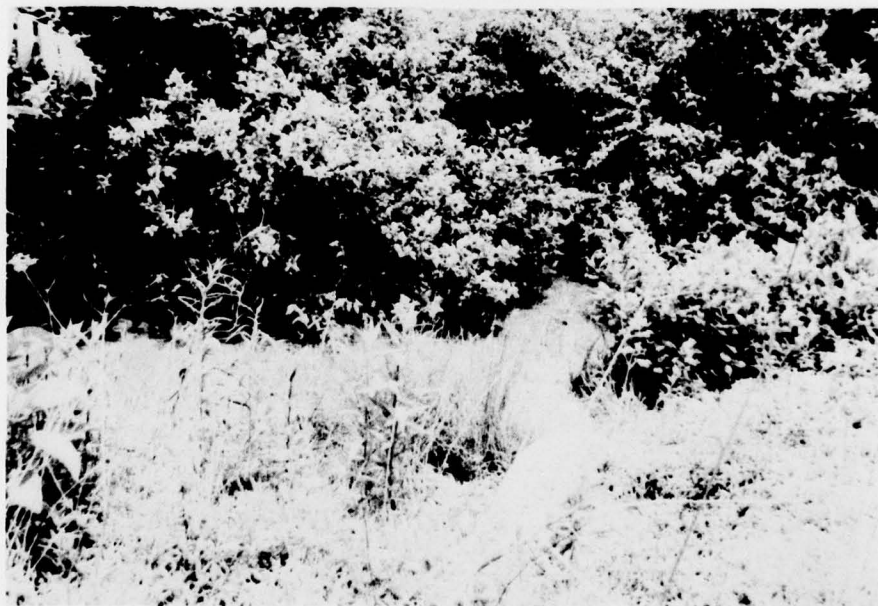
PHOTOGRAPH NO. 6  
Downstream

3.1.5 Reservoir Area: The reservoir area is partially surrounded by dense woods with several areas of beach and open fields. The area downstream of the dam, between the toe and the pump-back pool, was generally damp to soggy. There were no boils or evidence of flowing water.

VISUAL EXAMINATION OF	OBSERVATIONS	REMARKS OR RECOMMENDATIONS
CONDITION (OBSTRUCTIONS, DEBRIS, ETC.)	Heavy growth of bushes.	
SLOPES	Side slopes approximately 10%.	
APPROXIMATE NO. OF HOMES AND POPULATION
